Reflective Cracking Testing Notes

Date: February 20, 2015

Project: Reflective Cracking Indoor Phase IV

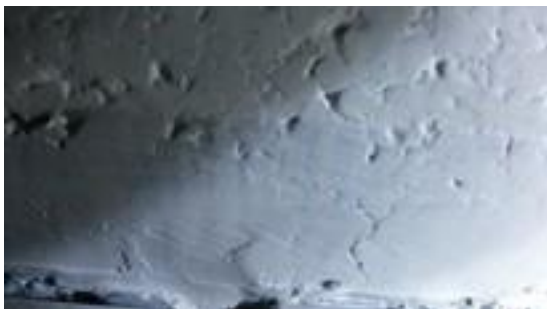
Figure 1. South Inner Vertical Edge.

The 12 mil formal test continued on the test item. On the South test section, the inner vertical edge remains unchanged from the pre-test condition, as shown in Figure 1 below. The South outer vertical edge shows no cracks, as shown in Figure 2. On the North test section, the inner vertical edge remains unchanged from the pre-test condition, as shown in Figure 3. The existing crack present within the North outer vertical edge shows minimal propagation since yesterday (2/19/2015) and continues to measure approximately 1 inch long, as shown in Figure 4 below. However, unlike yesterday, the sensor SG6-N-0 is now reading open.
